# **THE ASSESSMENT AND REPLACEMENT OF SUNGAI PINANG BRIDGE**

By: Ir. Leong Kok Khaw, Majlis Perbandaran Pulau Pinang  
Ir. Dr. Ng See King, K&N Consulting Engineers Sdn. Bhd.  
Ir. Ku Mohammad Sani bin Ku Mahamud, Evenfit Consult Sdn. Bhd.

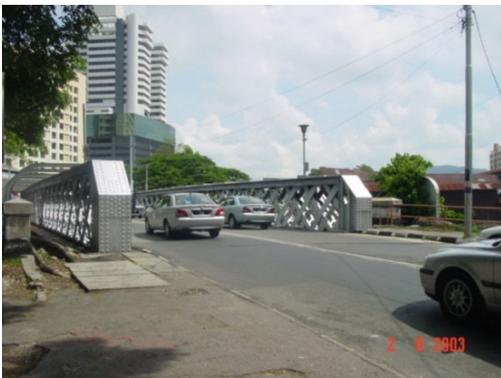
Fig. 1: The old Sungai Pinang Bridge

The existing Bridge over Sg. Pinang was constructed in 1907. The bridge consisted of the main bridge structure carrying two lanes of traffic and a timber-decked footbridge at either side (Fig. 1). The main load-carrying members of the bridge comprised two steel lattice girders of build-up sections. The bridge deck of "steel buckled plate" construction was supported by cross-girders (Fig. 2), which transferred the deck load to the lattice girders. The skewed bridge deck ( $17^\circ$  skewness) was supported at two ends by masonry abutments sitting on piles.

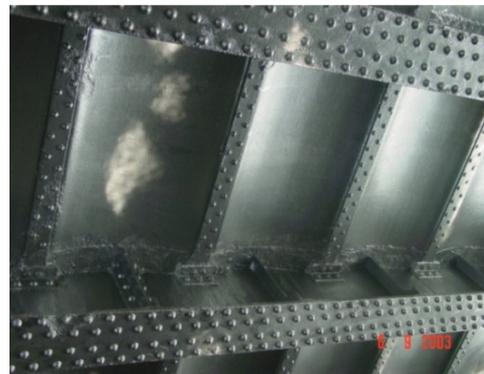
Fig. 2: Underside of the bridge deck showing steel buckled plate

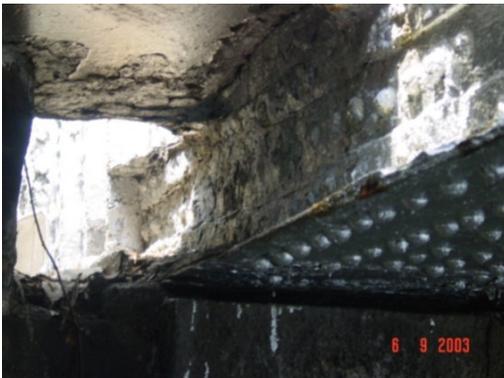
Fig. 3: Corrosion at bottom chord of lattice girder at the support (newly painted)

Inspection of the bridge revealed that it had varying degrees of corrosion. The main damage to the bridge was severe corrosion of the steel sections at the bottom chords and supports of the lattice girders, as well as connections between the cross girders and the lattice girders (Fig. 3 and 4). These were areas where water was easily collected but took longer time to dry up thus providing a good environment for promoting corrosion. This severe corrosion problem would have greatly undermined the integrity of the bridge and thus reducing its load carrying capacity.

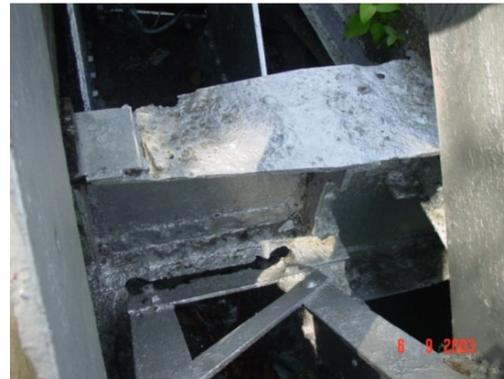
Fig. 4: Corrosion at connection of cross girder and main lattice (newly painted)

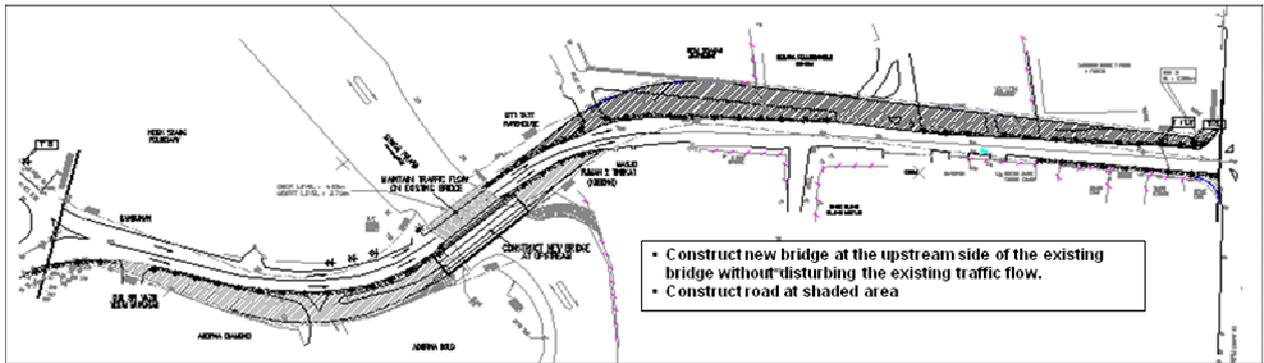
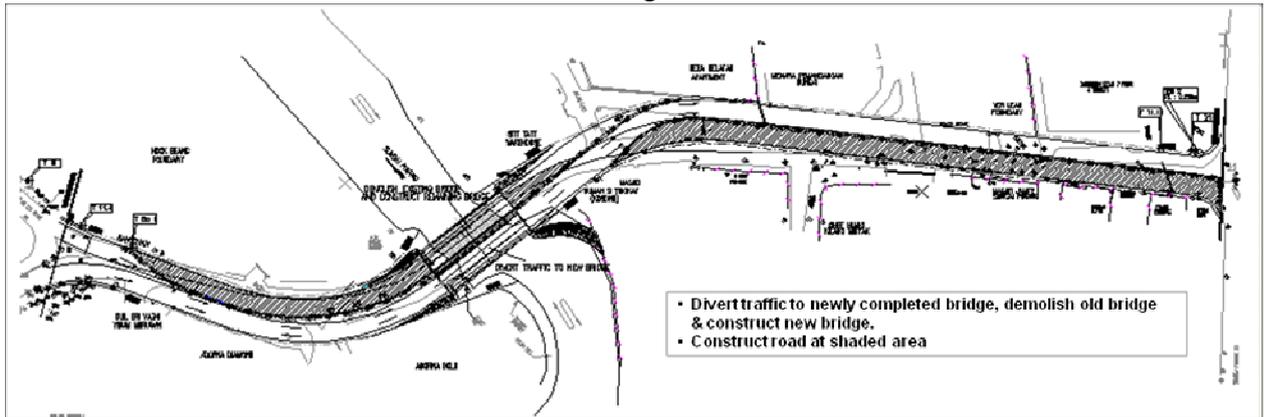
Fig. 7: Stages of construction

a: Stage 1

b: Stage 2

The construction work was carried out in two stages (Fig. 7). In Stage 1, the new bridge was constructed at the upstream of the existing bridge. Traffic was allowed to use the existing bridge and the existing Jelutong road as the road was also constructed in stages without disturbing the existing traffic.

In Stage 2, the traffic was diverted to the newly completed bridge and road. The old bridge was then demolished to make way for the construction of the second bridge. The remaining part of the new road was also constructed in this stage.

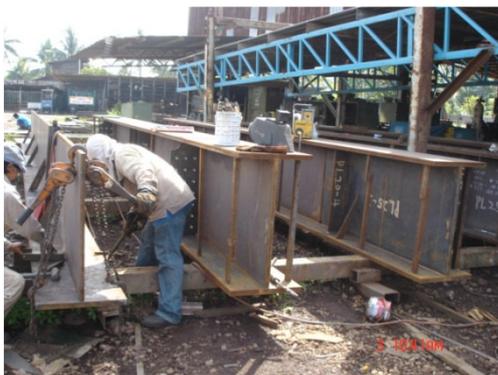
Fig. 8: Fabrication of the bridge

The bridge was fabricated off site in Seberang Perai (Fig. 8). NDTs such as magnetic particle inspection, dye penetrant inspection and ultrasonic scanning examination were conducted at the fabrication yard (Fig. 9). Besides the tests at the yard, cut-out samples were brought to the laboratory to conduct tensile, bend and charpy tests.

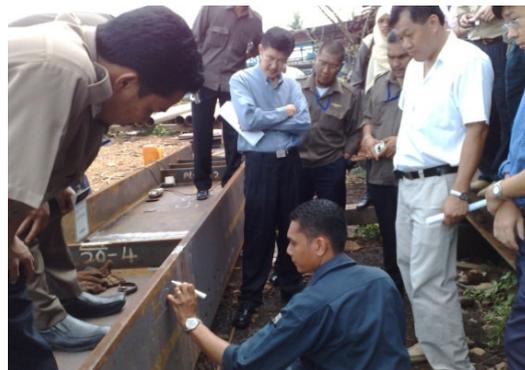
Fig. 9: Non-destructive testing witnessed by MPPP, JKR and the Consultant

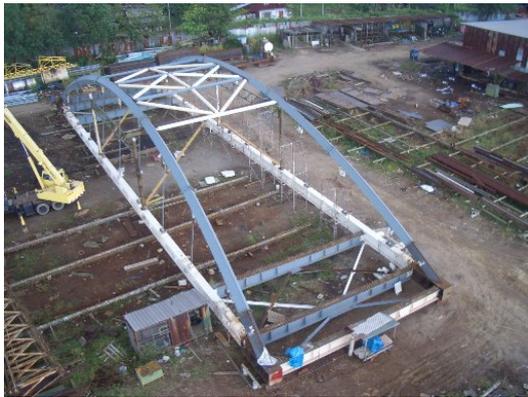
Fig. 10: Trial installation of the bridge at the fabrication yard

When the fabrication of the bridge components was completed, the bridge was first assembled at the yard before being brought to site to ensure that all the connections fitted perfectly (Fig. 10). The assembly involved constructing the end supports and two equally spaced intermediate supports for the longitudinal girders. Then the longitudinal and the end transverse girders were assembled on the supports. The main arch was then erected starting from the end and finishing at the centre of the arch ring while being temporarily supported by a portal frame structure. This was followed with fixing of the arch lateral bracings and

hangers to complete the temporary assembly of the bridge. The bridge was then dismantled and brought to site in transportable pieces for final assembly.

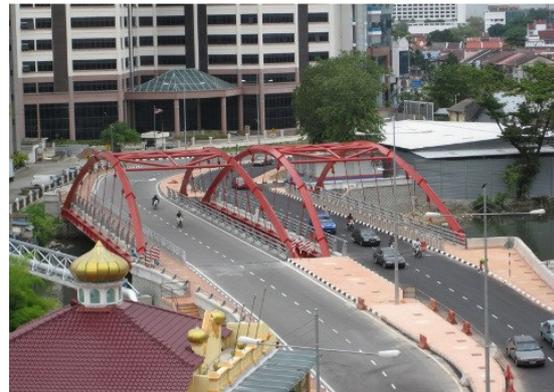
Fig. 11: The completed new Sungai Pinang Bridge

The completion of the new Sungai Pinang Bridge marked the end of a series of engineering activities within the life cycle, which started with general inspection; followed by detailed inspection and structural assessment; design of the new bridge; and finally its construction (Fig. 11). Future inspection and maintenance are expected within the next life cycle of the bridge, thus specific features, for example, sufficient headroom for inspection and jacking of the bridge deck, were incorporated in the design. The project also presented a good example on the engineering processes that were undertaken by MPPP before a decision was made to replace the old Sungai Pinang bridge. The whole process is documented in this paper and it is hoped that it can serve as a good guide for bridge owners before making decisions in bridge replacement. □
