BRIDGE PROBLEMS IN MALAYSIA

Evenfit Consult Sdn. Bhd.

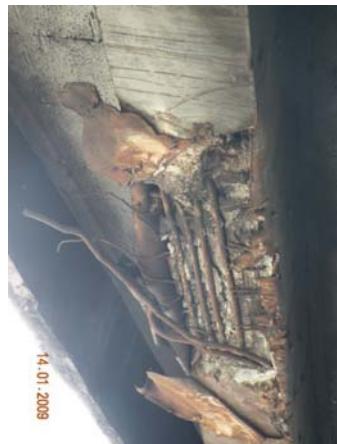
Fig. 1: Damage at underside of a beam in K.L. due to vehicular impact

Damage of bridge components by impact of vehicles is common for urban bridges. Fig. 1 and Fig. 2 show some recent examples. Vegetations growing in bearing shelves of abutments and piers is also very common in Malaysian bridges (Fig. 3). Their presence does not actually cause any physical damage to the bridge component. However, the roots tend to collect dirt and retain water which can cause long term durability problem.

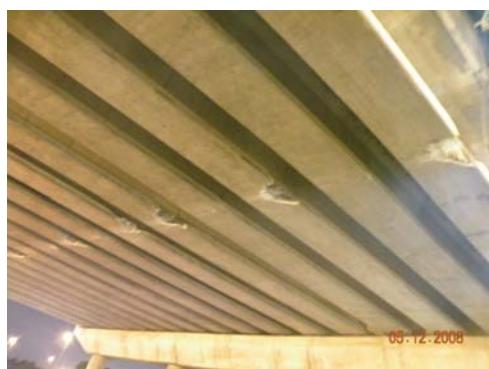
Fig. 2: Damage at underside of beams of a bridge in Shah Alam due to vehicular impact

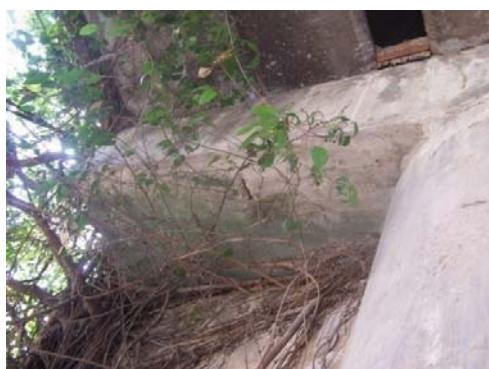
Fig. 3: Vegetation growth at bridge abutment

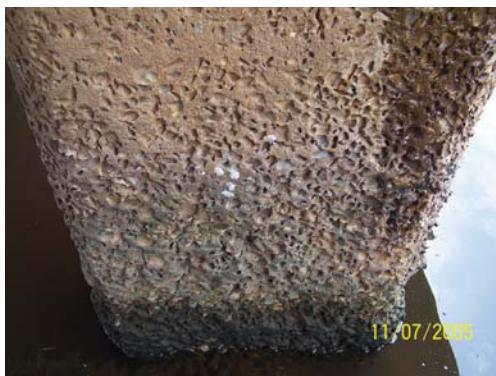
Fig. 4: Acid attack of lime stone aggregates

The majority of bridges in Malaysia are of concrete construction. Contrary to the belief of the general public, concrete does have durability and maintenance problems. Concrete may be susceptible to direct chemical or acid attack as seen in Fig. 4 , but by and large, cracking and spalling of concrete are most common in Malaysia.

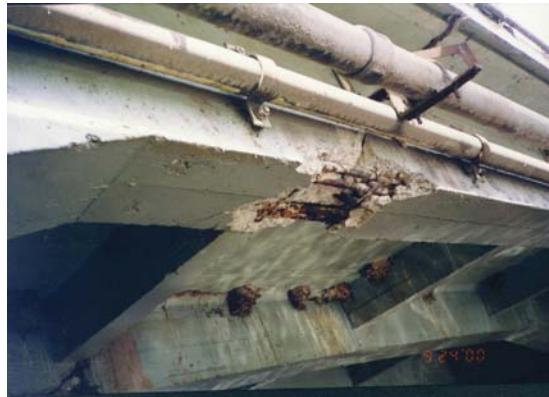
Fig. 5: Flexural and shear problem in beams

In structural design the endeavour of the designer is to ensure that the structural member has a resistance R that is at least equal to the load effect S . Conceptually when $R < S$ cracks would form, the nature and pattern of which depend on whether the load effect of concern is bending moment, shear or torsion etc. We thus have cracks that can be identified as flexural (bending), shear and torsional. Pictures in Figs. 5 to 10 show examples of load induced cracks.

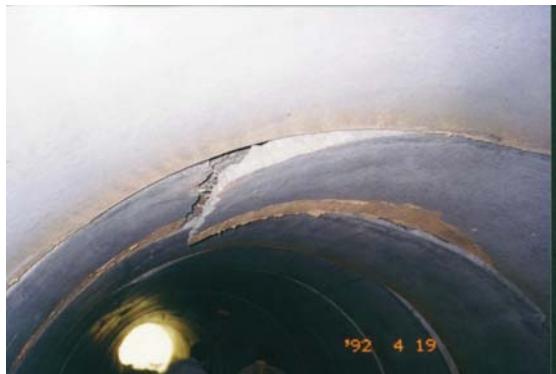
Fig. 6: Flexural problem in RC culvert (note tension crack at the crown)

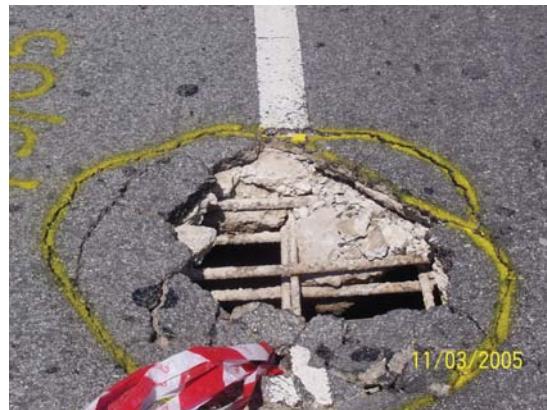
Fig. 8: Pot hole in the deck slab initiated by cracks similar to Fig. 21

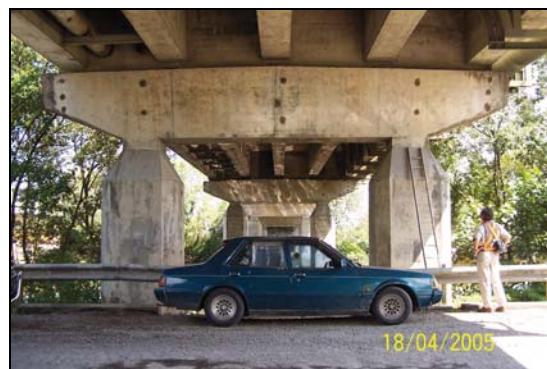
Fig. 9: Cracks in the reinforced concrete bent caps

Cracking in the reinforced concrete bent caps of a bridge in J.B. and at MRR2 had led to the interest in *deep beam* among local engineers. ACI Structural Journal had also reported on a similar type of cracking that occur in Texas highway bridges [6]. A deep beam is defined as “a beam in which significant amount of the load is carried to the supports by a compression thrust joining the load and the reaction” [7]. The transition from ordinary beam behaviour to deep beam behaviour is imprecise, and ACI Sec. 10.7.1 specifies that for design purposes an effective span/depth ratio of 1.25 (for simple spans) and 2.5 (for continuous spans) be used [7]. According to the literature, the “plane section remains plane after bending” assumption (the Bernoulli hypothesis) no longer holds for a deep beam. The conventional design practice is thus not suitable for a deep beam. In a deep beam design a strut and tie model is recommended. The reader is referred to a presentation by Fu entitled “The Strut-and-tie model of concrete structures” [8].

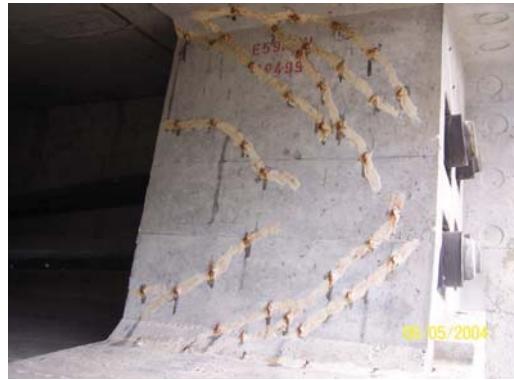
The anchorage zone in the box girder is also within the so-called “D-region” that is descriptive of the deep beam. Fig. 11 shows the crack patterns resembling the stress trajectories under a concentric load. The repair by epoxy indicated that the cracks were likely to have occurred during construction.

Fig. 11: Cracks at the anchorage zone (sealed with epoxy) of a box girder

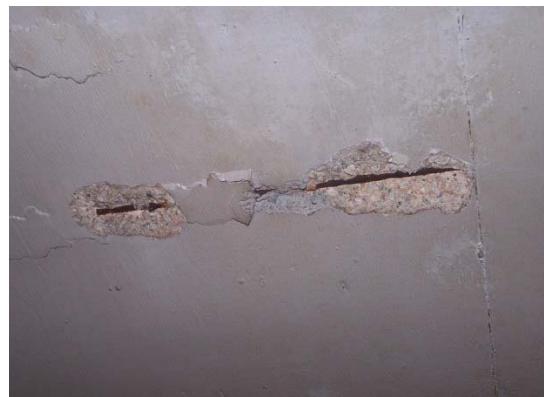
The literatures on concrete durability discuss the “passivation” (and thus protection) of the steel reinforcement within the alkaline environment of the concrete mass. When the passivating barrier is disrupted by the ingress of atmospheric carbon dioxide in the presence of water, the environment becomes “depassivated” as evidenced by the drop of pH value from around 12 to below 11. The steel reinforcement corrodes and expands causing the concrete to crack, delaminate and spall (Fig. 12). This is known as *carbonation*.

Fig. 12: Cracks and spalling of concrete due to carbonation

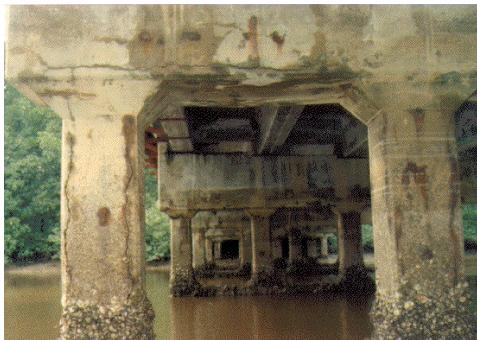
In another instance the aggravating agent is the chloride ion. Regardless of whether the alkalinity is available the presence of chloride ion exceeding the threshold value would start the electrolysis process and cause the steel reinforcements to corrode. Again, cracking is the result (Fig. 13).

Fig. 13: Cracks at pier columns due to corrosion of reinforcement as a result of chloride attack

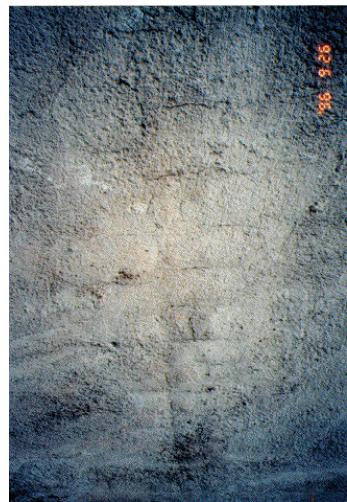
Fig. 14: Plastic settlement cracks on a bridge deck typically follows the line reinforcement

While cracking problems mentioned above have their source from external actions (loading or movement) or the environments, there are cracking due to the intrinsic properties of the concrete. The UK Concrete Society has published a comprehensive report on the types of intrinsic cracks in concrete [9]. In Malaysia three types of intrinsic cracks are common: plastic settlement/shrinkage (Fig. 14 / Fig. 15), early thermal contraction (Fig. 16) and long-term drying shrinkage.

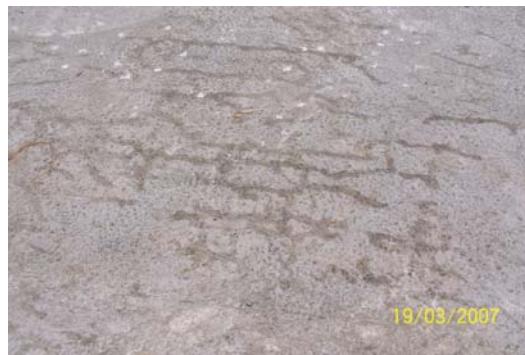
Fig. 15: Plastic shrinkage cracks on top of the deck slab

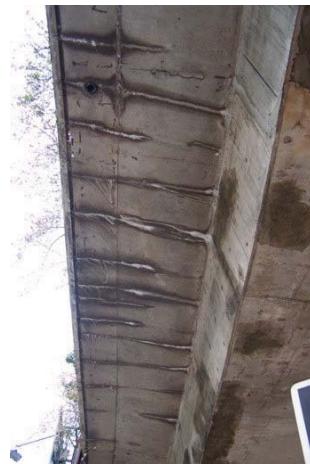
Fig. 16: Early thermal contraction cracks at underside of cantilever slab

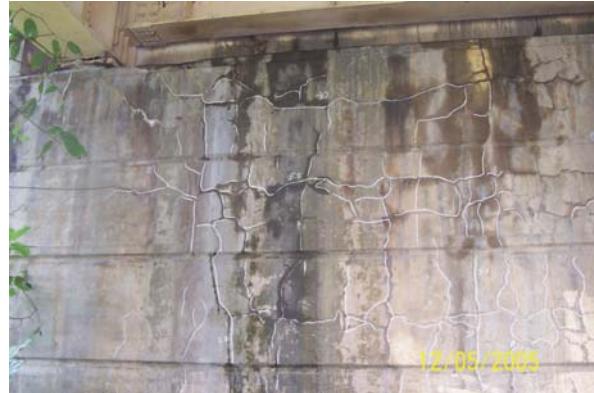
Random map-like crack from alkali silica reaction (ASR) is also a type of intrinsic cracks, although it is not so common. The first case of ASR was reported to occur at the pile head of Sg. Pontian in Rompin in the Axle Load Study (1986-87) as a suspect case [10]. A full analysis was later carried out by Dr. Hashim of Universiti Malaya and later JICA [11] which confirmed the presence of ASR. A few suspect cases in Sabah, such as Tamparuli Bridge (Fig. 17) and Datuk Salleh Sulong Bridge were detected during the Bridge Management Study for Sabah and Sarawak in 2004-2006.

Fig. 17: Random map cracking (chack line drawn alongside) at the abutment of Tamparuli Bridge resembling that of AAR

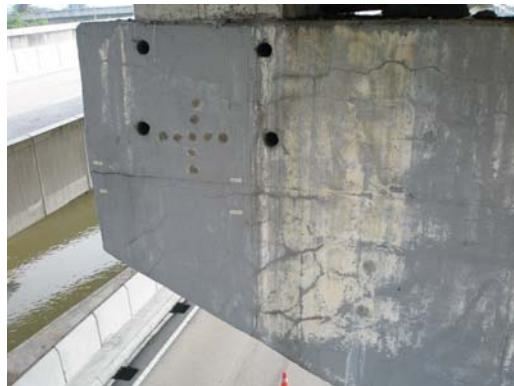
MRR2 is certainly not the only bridge in Malaysia that experiences this type of problem. The authors had encountered a bridge with similar cracking pattern (see Fig. 18), and had DEF confirmed in the laboratory.

Fig. 18: Multiple cracks of a bridge pier in K.L. that was caused by DEF

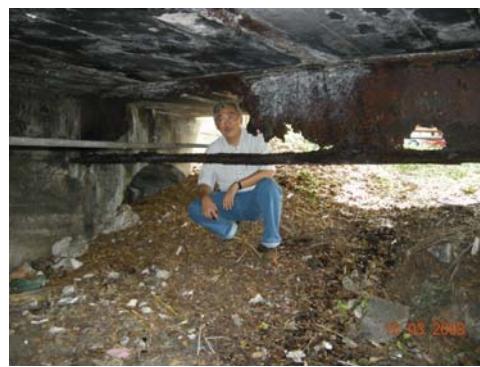
Corrosion and loss of section is the most common type of problem associated with steel members (Fig. 19). In Peninsular Malaysia, most of the steel bridges particularly the *steel buckled plate* bridges had been replaced after the Axle Load Study in 1988. Today, the states of Sabah and Sarawak still have a great number of steel bridges and corrugated multi-plate culverts (CMP). The majority of the steel truss and girder bridges are in good condition except for some corrosion at the connection and damage from vehicular impact in the case of steel truss bridges (Fig. 20). However, the steel truss bridges appear to be under-strength as indicated by cracking in the concrete deck slab (Fig. 21) and excessive vibration.

Fig. 19: Total loss of section of a steel girder bridge in Ipoh

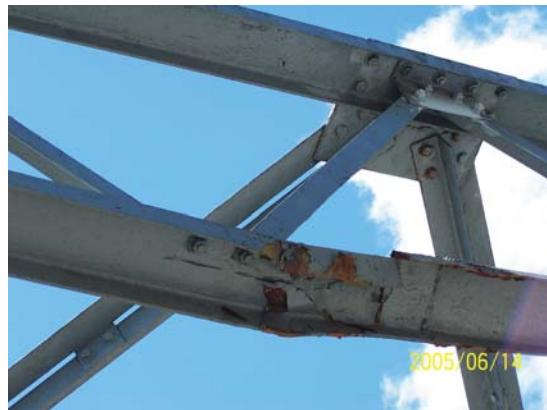
Fig. 20: Deformation of member of a steel truss bridge in Sarawak due to vehicular impact

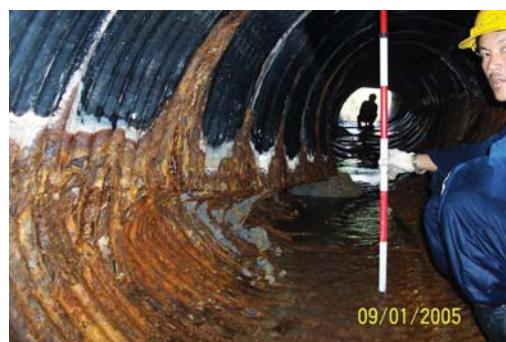
In the case of CMPs, the main problem is corrosion (Fig. 22). The loss in capacity due to the corrosion might have been the cause of the structural failure (Fig. 23). No matter, the CMPs are progressively being replaced with concrete culverts.

Fig. 22: Widespread corrosion at bottom half and joints of a CMP

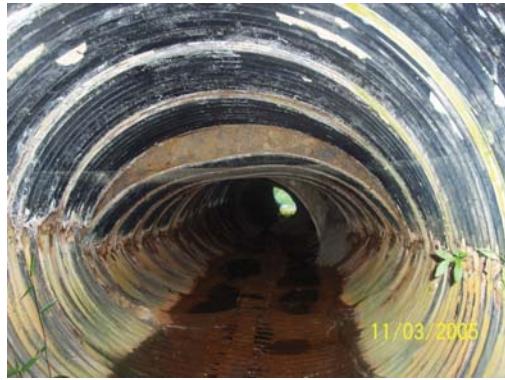
Fig. 23: Failure of CMP due to loading

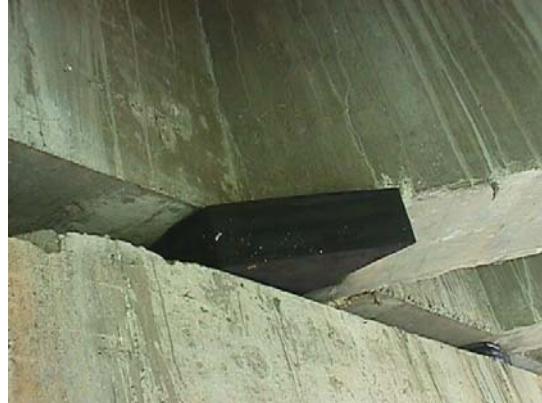
Problem of walking bearings is rather common in Malaysian bridges (Fig. 24). Each case may be unique but all happened in the situation when the bearing is not uniformly loaded. Many methods had been used to overcome the problem but they largely involve provision of restraint to the existing bearings. Leow et al. presented a case of walking bearing involving diamond shaped rubber bearings [13].

Fig. 24: Walking of the diamond shape bearing

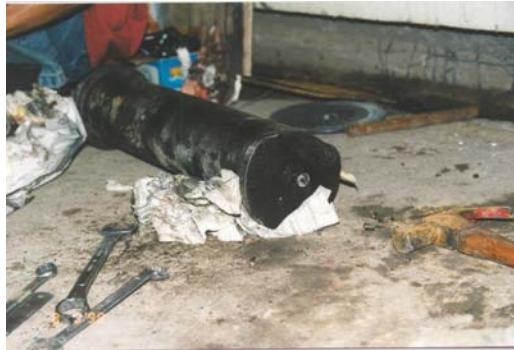
The problem of walking bearing mainly involves elastomeric (rubber) bearings. There were, however, some bearing problems related to mechanical bearings. In Jambatan Ahmad Shah at Termeloh, the roller pins of two of the *HiLoad* type (a trade name) bearings were displaced (Fig. 25). A bold decision was made by JKR to replace all the four mechanical bearings by

Fig. 25: Roller pin of the mechanical bearing for Ahmad Shah Bridge

laminated elastomeric bearings (Fig. 26). Details of the problem and its solution were reported in Lee et. al. [14]. It is interesting to report that the replaced rubber bearings slowly walked out of their positions about a year after the celebration of the apparent successful installation of the new bearings. The problem was finally nailed down by jacking up the bridge deck to reinstate the rubber bearings, somewhat deformed – and addition of two sheets of sand paper, on the top and bottom faces of each bearing. Chang [15] has a report on the works involved.

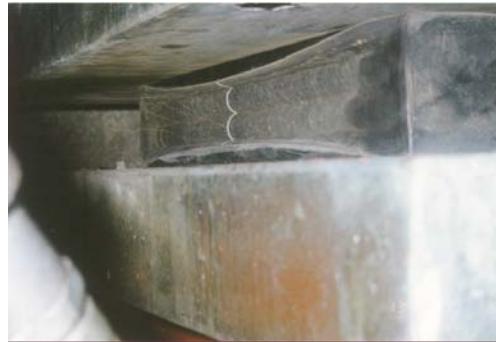
Fig. 26: Newly replaced laminated elastomeric bearing at Ahmad Shah Bridge

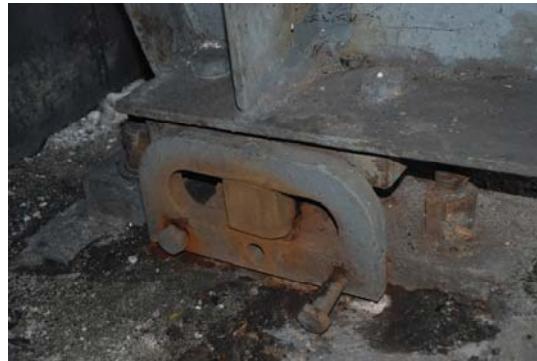
In another case involving an *autopont* bridge in Batu Gajah, the bolts holding the restraining frame of some mechanical bearings at the fixed abutment gave way causing the bridge to spring up and settle with each passage of a heavy vehicle (Fig. 27). The problem was causing much nuisance to the bridge user but the solution was relatively straight forward involving reinstatement of the restraining frame [16] (see Fig. 28).

Fig. 27: Damaged mechanical bearing of the *autopont*

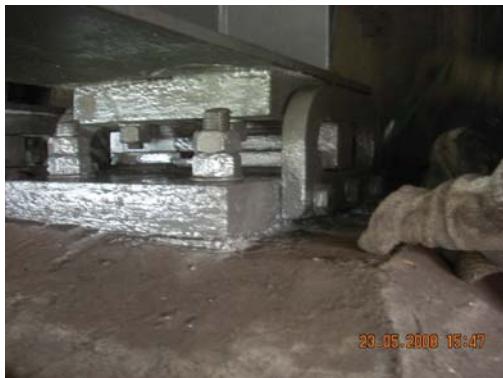
Fig. 28: Bolts and restraining frame of the bearing in the *autopont* bridge reinstated and painted

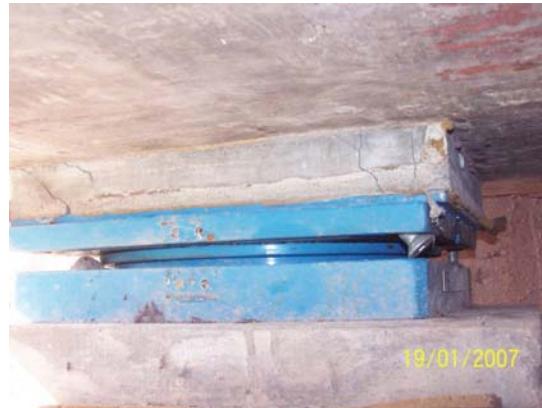
As the bridges in Malaysia are designed for longer spans, more pot bearings are being specified by the designers. Not many cases of problems with pot bearings had been reported. Three bridges in the same locality having a high fill at each abutment had their pot bearings damaged, caused by movement of soil behind the abutment wall (Fig. 29). In one of the bridges the concrete parapet walls were crushed (Fig. 30), testifying to the great force from the soil movement. Pot bearings over the piers were not spared because the deck movement was transferred from the end spans to the intermediate spans in a domino effect.

Fig. 29: Anchor bolts and plinth damaged

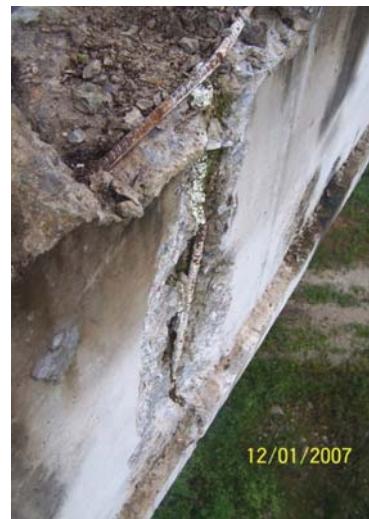
Fig. 30: Crushed parapet at the expansion joint due to movement of the deck

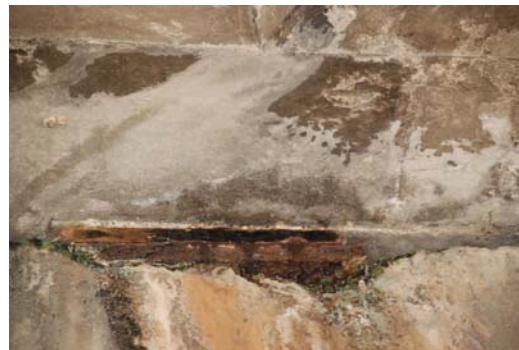
From the authors' observation, the bearing shelf is the most forgotten part of a bridge in Malaysia. The dirt and debris collected at the bearing shelf tend to retain water causing steel bearings to corrode. Fig. 31 shows a picture of a "frozen" bearing.

Fig. 31: Frozen bearing

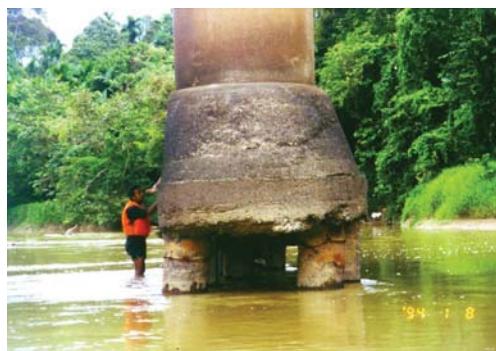
Scouring of river bed, either general scour or local scour around the piers causes instability of the bridge (Fig. 32). Bridges that the authors had been required to investigate include:

Fig. 32: General scouring of river bed at Sg. Jeniang

Chiew et. al. [17] had presented the JKR experience in facing hydraulic problems in Malaysia. Revetment of Pukin River Bridge, Keratong River Bridge and Plentong River Bridge are cited as case history. It is later learned that the Pukin River Bridge was badly scoured at both abutments during heavy flooding in December 2006 [18]. As a solution two spans were added in February 2008. For update, Jeniang Bridge (Fig. 32) had also been replaced.
