STRUCTURAL ASSESSMENT FOR AN OLD STEEL RAILWAY BRIDGE UNDER STATIC AND DYNAMIC LOADS USING FIBRE OPTIC SENSORS

ABSTRACT This article presents the structural assessment of an existing old steel railway bridge in Malaysia using fibre optic sensors. The steel bridge was built more than a century ago and the bridge structural drawings and other documentations were lost over the years. Keretapi Tanah Melayu Berhad (KTM), the Malaysian rail operator was upgrading the railway line to cater for heavier and faster locomotives. The bridge is subjected to a potential risk of structural health deterioration or fatigue due to corrosion and long service period in such a high humidity country. Full scale static and dynamic tests using locomotives were carried out to assess the structural integrity of the steel bridge. Two types of optical sensors were used. Discrete and distributed fibre optic sensors were mounted on critical steel panels to monitor the change in strain of these members under dynamic and static loads. The discrete sensor, Fibre Bragg Grating (FBG) strain sensors were able to measure the change in strain at 1000 Hz frequency, and were used during the dynamic test where a locomoti

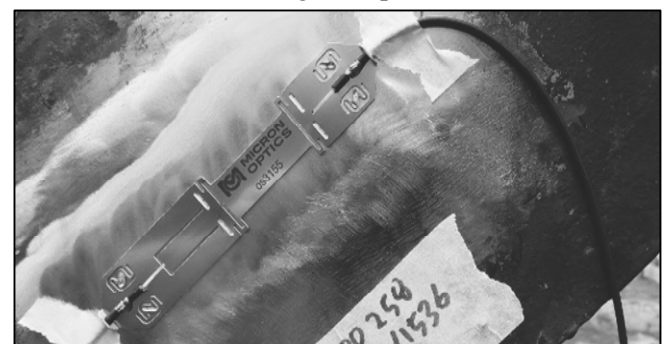
Figure 3 Optical Strain Gauge (os3155) installed on the neutral axis of steel bridge components

There were ten FBG sensors, i.e. the optical strain gauge (os3155) with a gauge length of 50 mm, installed on the smooth surface of the uniform steel components (Figure 3). A loop of DFOS sensor was instrumented on the bottom chord of the steel bridge with a total length of 31.4 m on both strain and temperature sensing cables. The DFOS readings were set to 5 ns spatial resolution (that is equivalent to 0.5m), 65,000

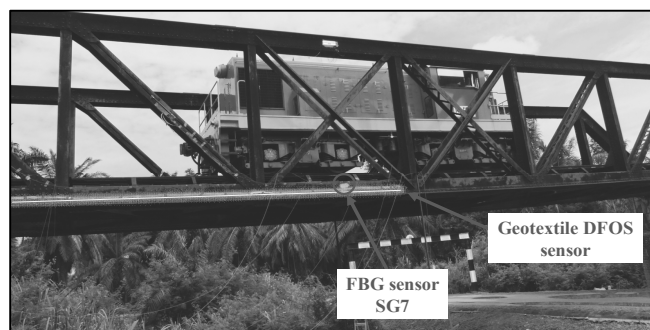
Figure 4 DFOS sensor mounted at the bottom chord of the old steel bridge and the FBG sensor SG7 is mounted very close to it at 14m from Abutment A, in order to

compare the strain results obtained from different type of sensors.

Table 3 summarized the maximum strain obtained during the static load test using FBG sensors (SG7) and DFOS. The SG7 was placed very close to the DFOS geotextile sensor, assuming the two sensors should be able to capture similar data. It can be observed that the maximum strain obtained during the static load test is not more than $250 \mu\epsilon$ which is far from the failure limit of steel. On average, the percentage difference between the results obtain using FBG and DFOS is only 4.5%.

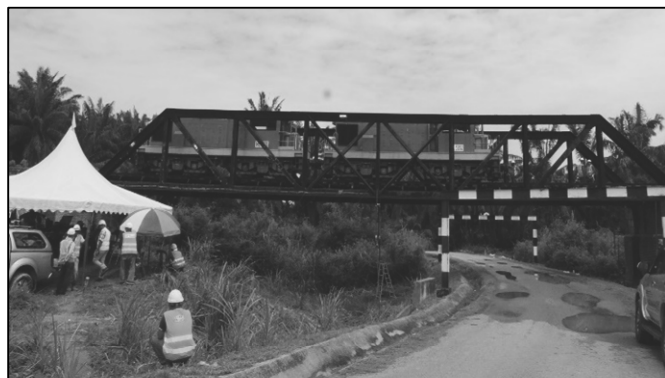
Figure 6 Example of Load Test Arrangement: Case 13 - Double Locomotive Static Test 25 m from Abutment A

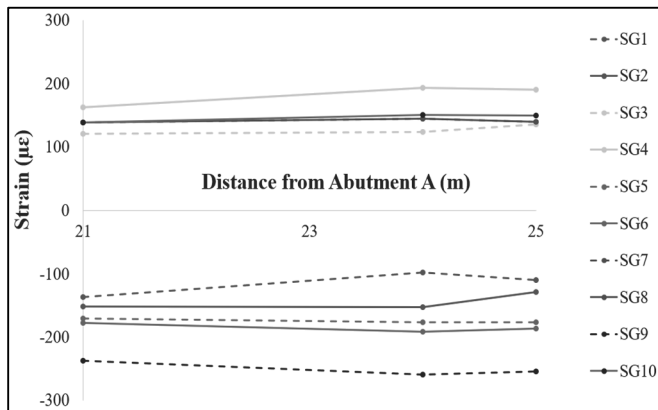
Figure 8 Strain measurements (static test double locomotive)

Figures 7-9 show the measurements of strain using FBG sensors when the locomotives were placed at different distance from Abutment A.

strain at SG9 and SG10 increased when the single locomotive moved closer towards them. However, SG9 constantly recorded higher strain values as compared to SG10. The strain has similar trend for double locomotive static load test. The maximum strain value $192.9\mu\epsilon$ was captured by SG4 during Case 7.

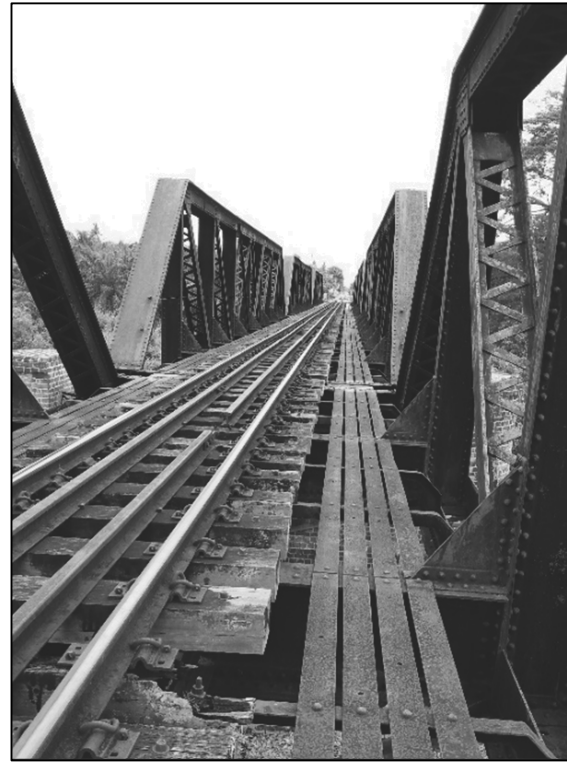
Figure 10 The connection and jointing system at the inner truss is more complicated than outer truss

As the strain gauges were placed at different sides of the steel members, the strain values are not the same but of very close magnitude. Generally, the inner components of the steel bridge (SG2, SG4, SG6 and SG8) experienced higher strain as compared to the outer members (SG 1, SG3, SG5, SG7). This may be due to the slightly uneven load distribution which may

be caused by the difference in joint and connection system at both sides of the steel components (Figure 10). For single locomotive static load test, the maximum strain recorded was $132\mu\epsilon$ at SG4 (Case 2).

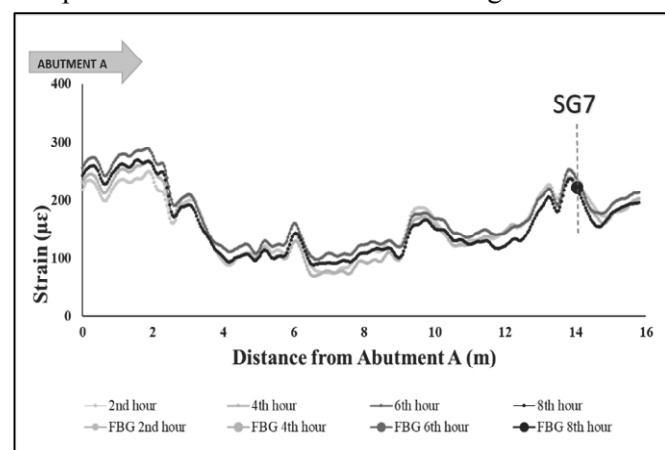
Figure 13 Strain measurement using DFOS and comparison to strain value obtained using FBG sensor

Figure 13 shows the result obtained from DFOS for Case 13. The double locomotive was placed at 25 m from Abutment A for eight hours. Strain was measured once the locomotive parked at the exact location, and readings were taken at an interval of two hours. From Figure 13, it is noticeable that while time passed, there is no significant change in strain pattern or trend. However, the magnitude of strain slightly increased. This is due to the creep effect experienced by the old steel bridge over the 8 hours. Table 3 shows the maximum strain collected during the static load tests of different load applied. Measurement were taken at an interval of two hours, i.e. 2nd, 4th, 6th and 8th hour. The DFOS captured a maximum strain reading of $237 \mu\epsilon$, which was mainly due to the creep effect.
